Our 2019 Plumbing Nemesis Returns in '22

In 2019 we chased the cause behind water dripping along the seam of the lower body panels of our 2017 Airstream Classic and making the water pump growl every twenty minutes to recharge the system. We chased that leak for five months!!

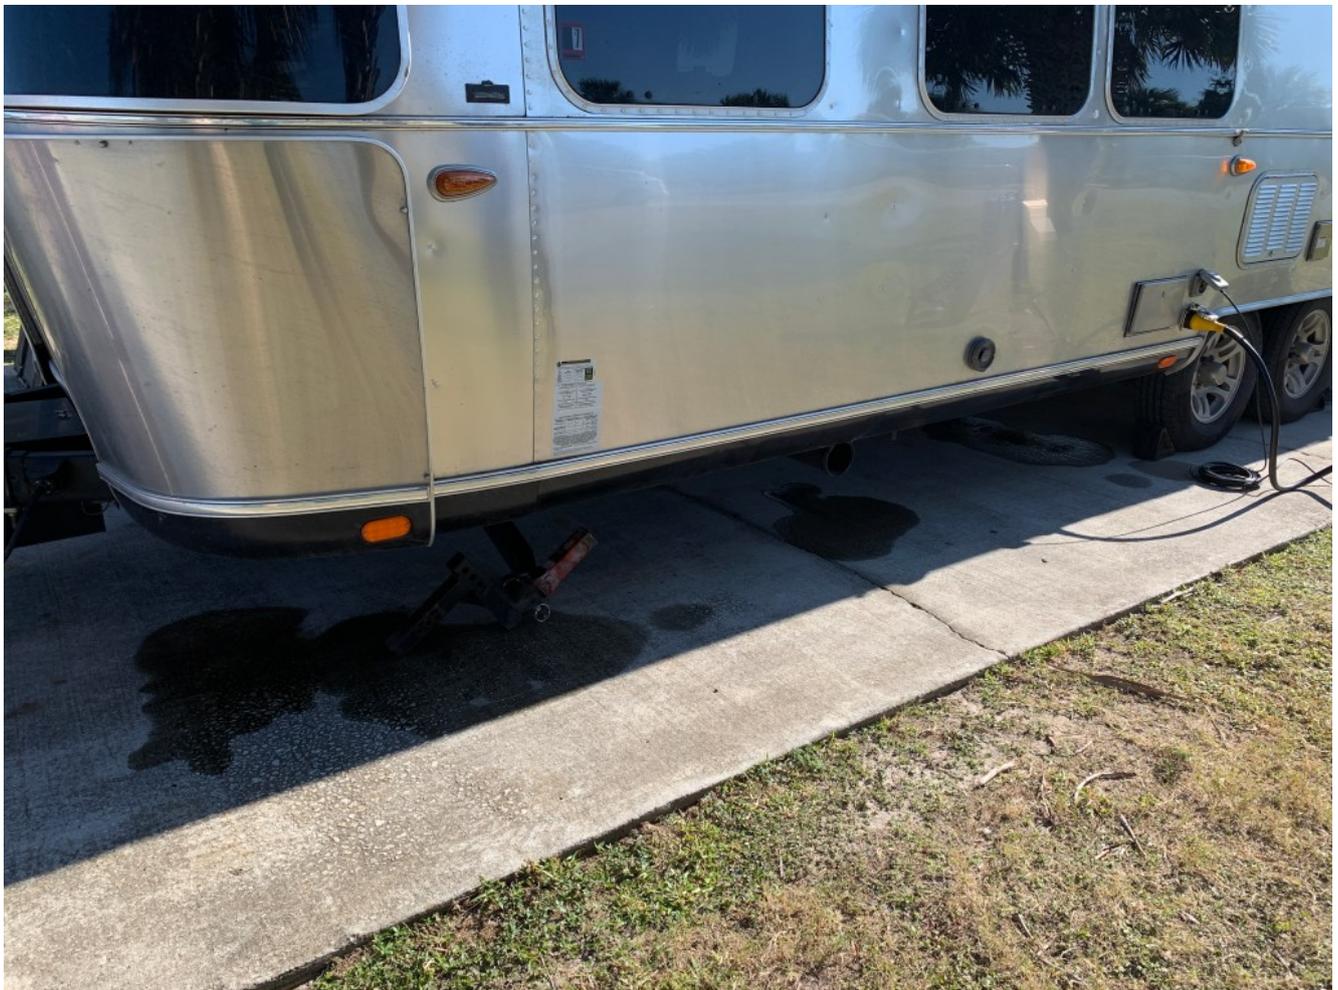
in 2019 water dripped from the panel seam under the trailer 3600 miles into our current trip and this morning we looked at each other and said, is the pump really supposed be making that noise a few times a day? This is a new pump. HmMMMM....

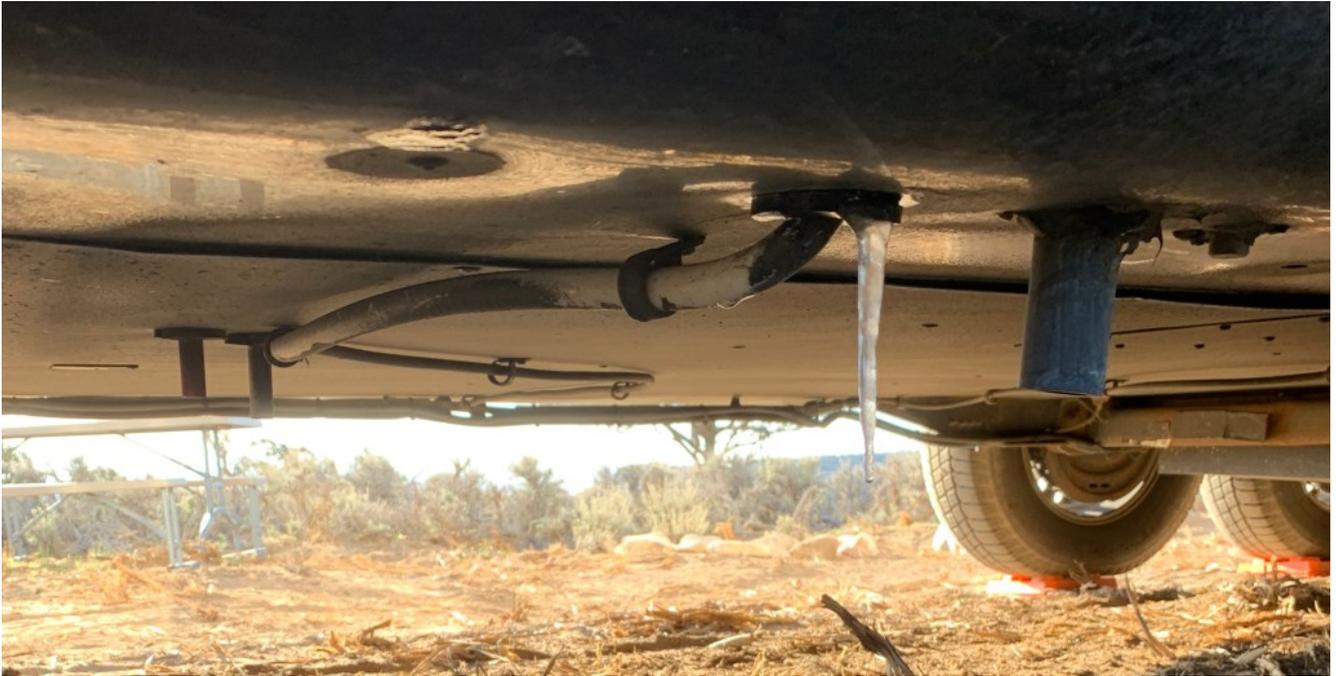
Last night's cold weather left us in no doubt – there was an icicle hanging from the bottom of the Airstream. Exactly where the old leak was. We got this! No searching for five months.

dead give-away – yes, we have a leak

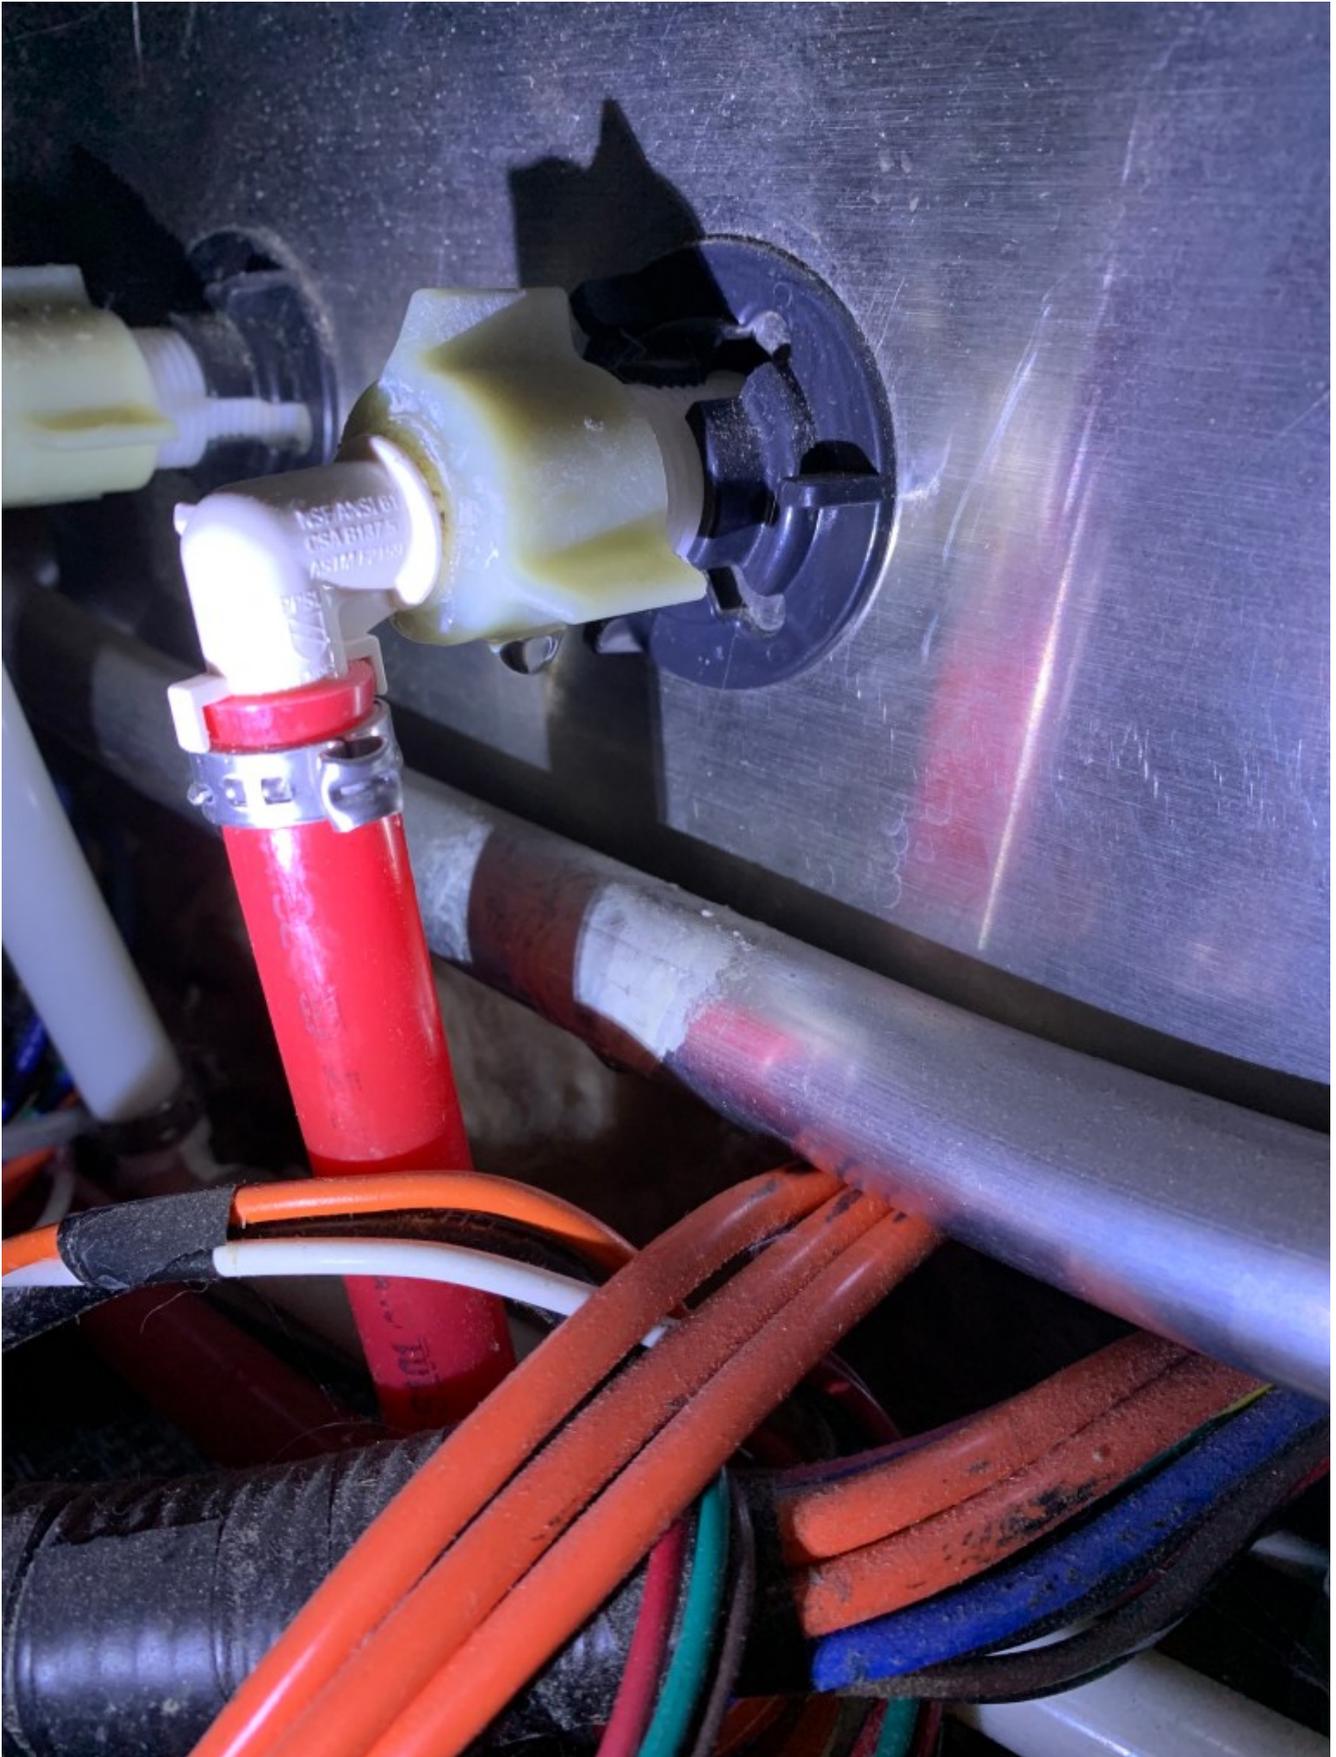
We pulled the bottom panel off the dinette next to the fridge – and discovered the hot water line to the exterior shower was dripping. Two years ago the leak damaged the electronics down here – so we propped the Firefly control panel on top of a Tupperware container, tightened a hand screw, and squashed a towel in the space to absorb the spilled water.

the culprit has left mineral stains behind!
This seems to happen when the roads are especially rough – which we had in New Mexico and Arizona. Our plan is to replace (beef up) the teflon tape on the fitting and monitor it.

The water seems to drip down the space between the floor and the wall insulation – so we don't see the telltale inside on the floor unless it has been leaking for a *long* time. Maybe we will add it to our departure checklist. ☐

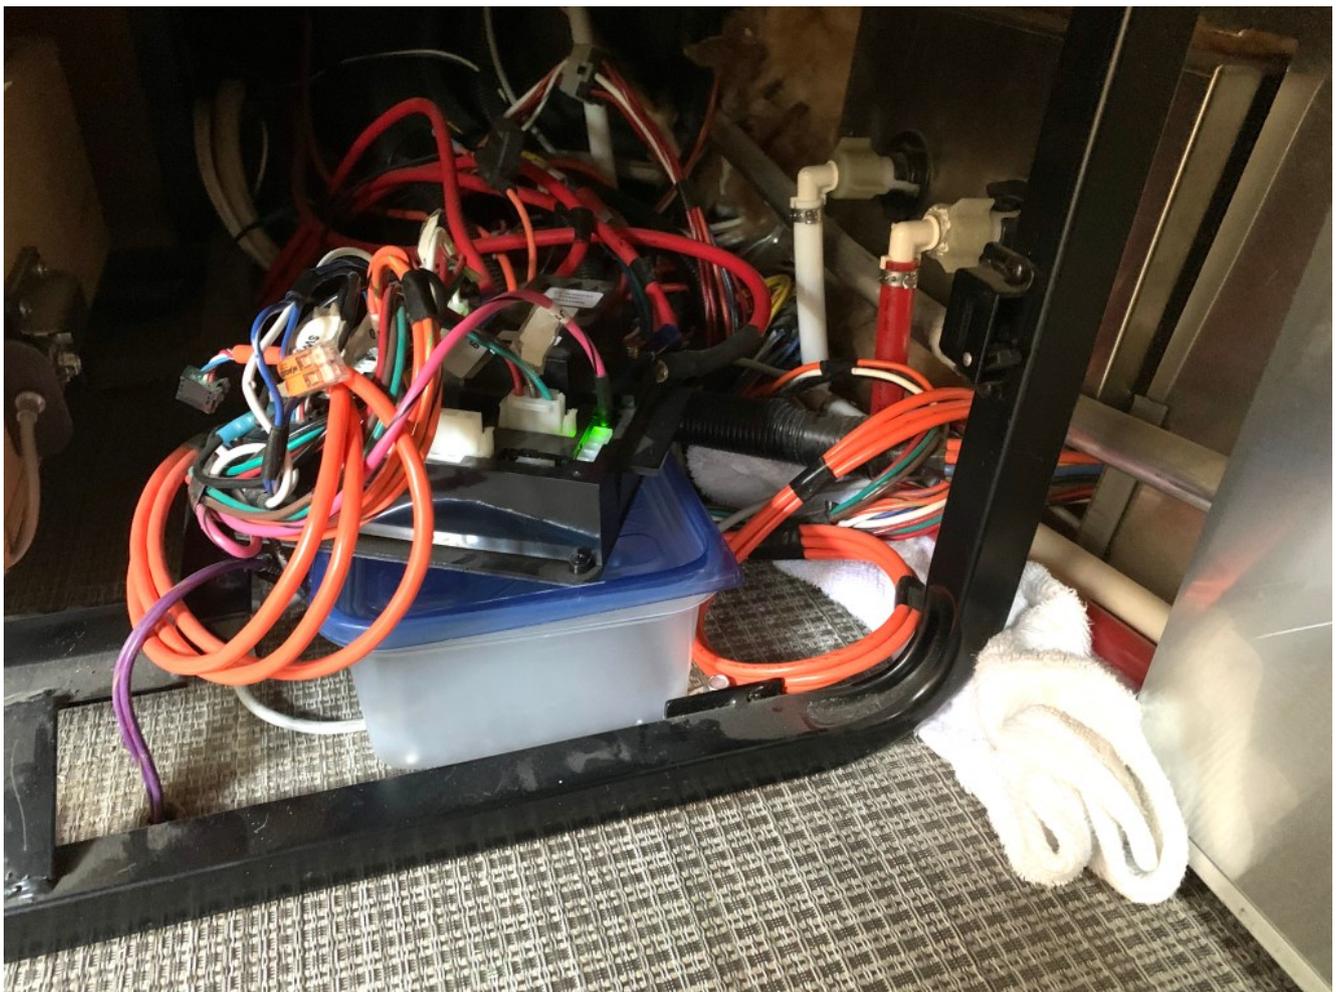
Firefly control panel up off the damp floor until I contrive a better solution
